Manhole Inspection Summary

Manhole # S13KK1013MH

Location Address: **4500 OAKFORD AVE**

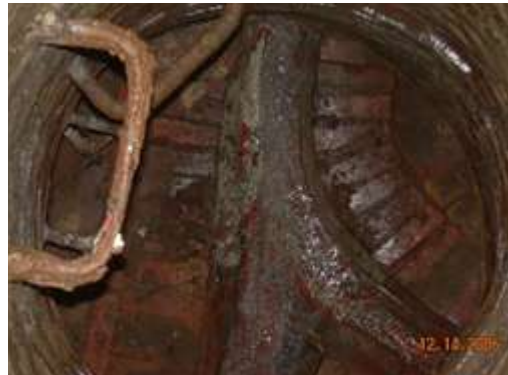
Top View

Evidence of surcharge - Bench debris.
Corroded steps.

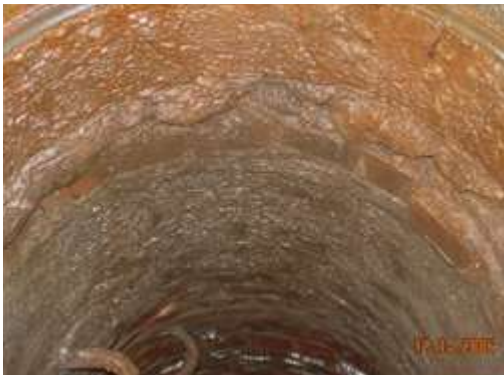
Defect

☒ **Leaks**

Condition: ☐ Sound ☐ Cracked ☐ Root Intrusion ☒ **Loose Brick** ☒ **Deteriorated**

Infiltration: ☐ None ☒ **Joint** ☐ Cracks ☒ **Mortar** ☐ Roots ☐ Wall

Frame leaks. Adjustment deterioration,
loose brick and infiltration. Corbel and
Barrel infiltration.

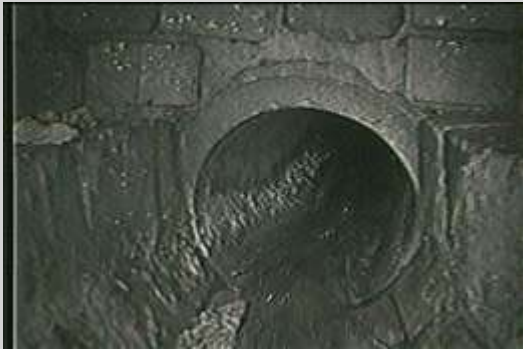
8 in. Circular Gravity Sewer Pipe Out @ 12 O'Clock

Deposits: ☐ None ☐ Mud ☐ Sludge ☐ Debris ☒ Grease

Silt Depth: **0** (in.) Deposits Extent: **Light**

Infiltration: **Evidence** Pipe Seal Cond: **Unknown**
